# Your survey and valuation report

25 Arcacia Avenue, Huxley, London NW1

22nd September 2021

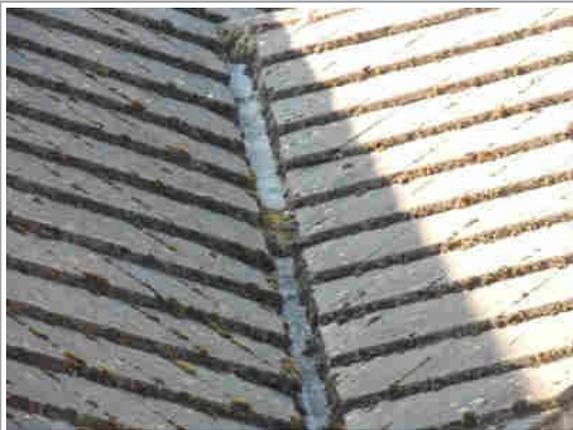
Debris in valley

Debris from the valley gutter should be removed to prevent overflows and blockages. Also, moss growth on the roof tiles should be removed. This impedes run off of rainwater, causes deterioration of the covering, leads to blocked rainwater goods which could cause water penetration.

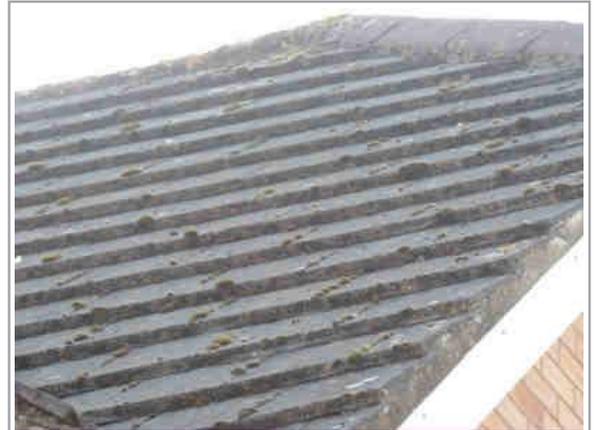
Moss

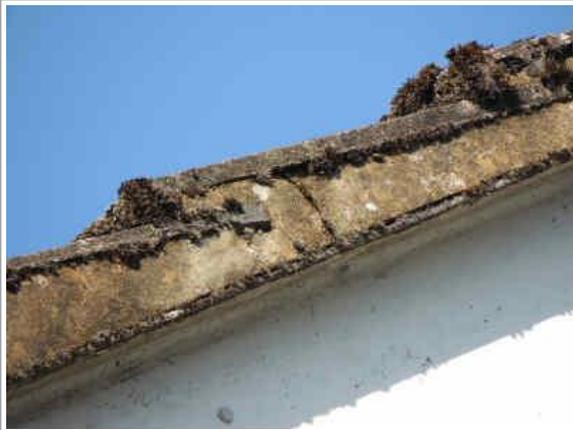
Cracked pointing

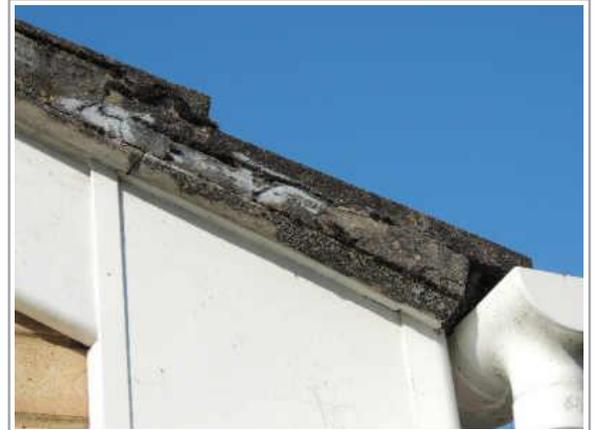
Worn pointing

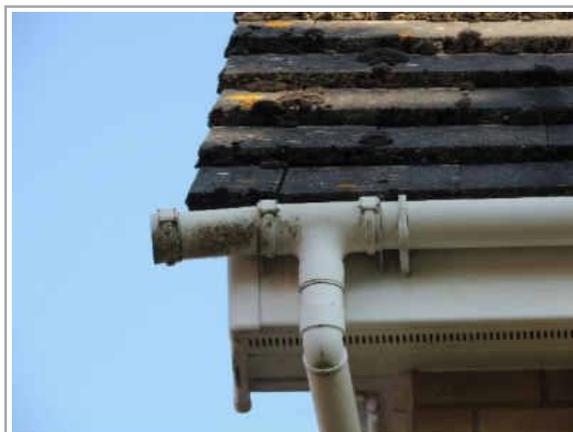
Re-align gutter

The rear corner section should be re-aligned to ensure proper discharge of rainwater.

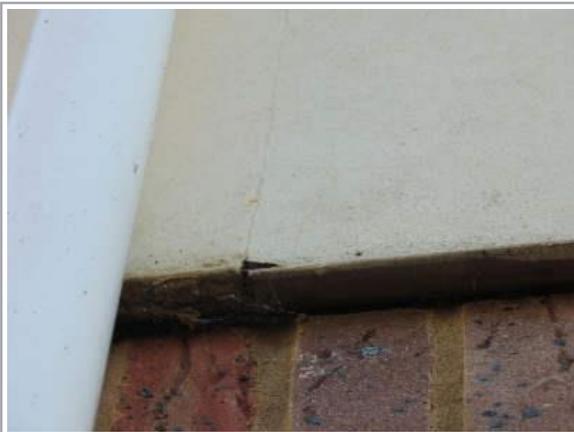
Some minor cracking to the render was noted which will need to be patch repaired in time.

Cracked render

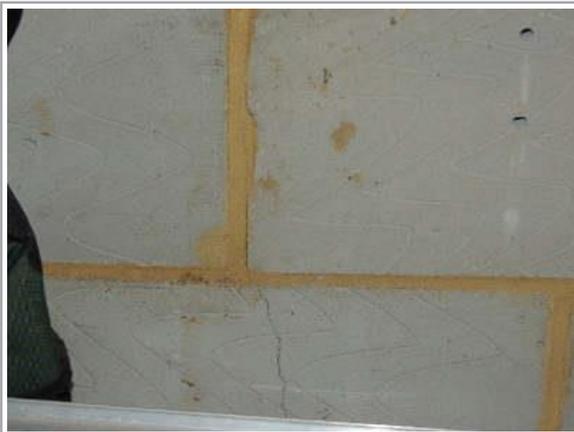
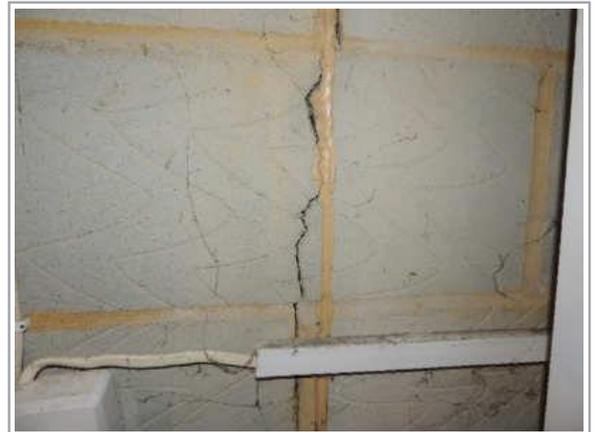
Internally to the garage, we noted some vertical cracking to the blockwork which is common as these blocks are very lightweight and exceptionally prone to cracking due to thermal expansion and contraction.

Cracks in garage

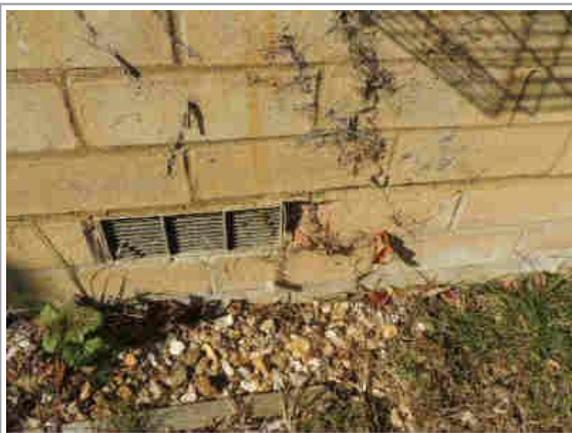
Some minor damage to the brickwork was noted which will need attention in time.

Minor brick chipping

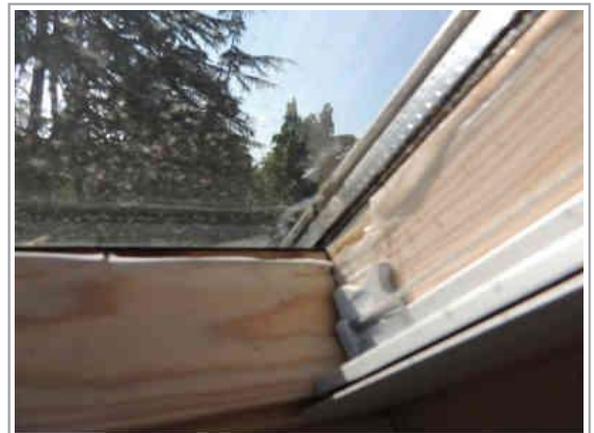
The timber Velux windows to the loft room are original and are suffering from some wear and tear. They would benefit from re-varnishing/overhauling.

Overhaul Velux windows

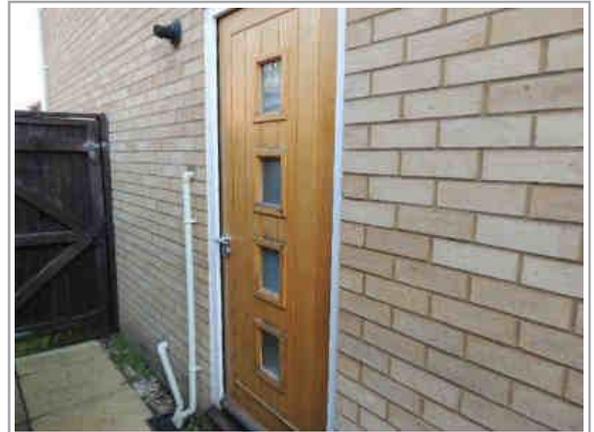
Some deterioration was noted to the side door and it will require redecoration.

Side door

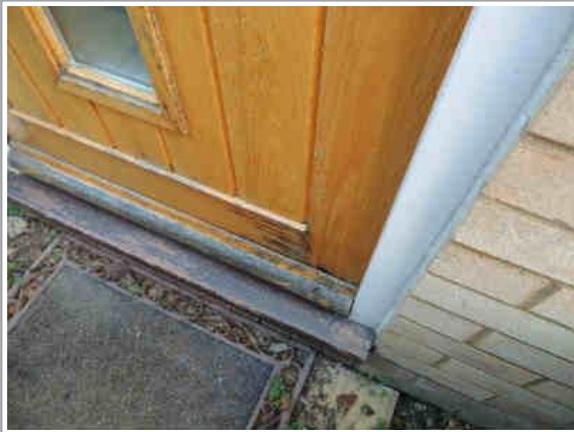
Worn decoration

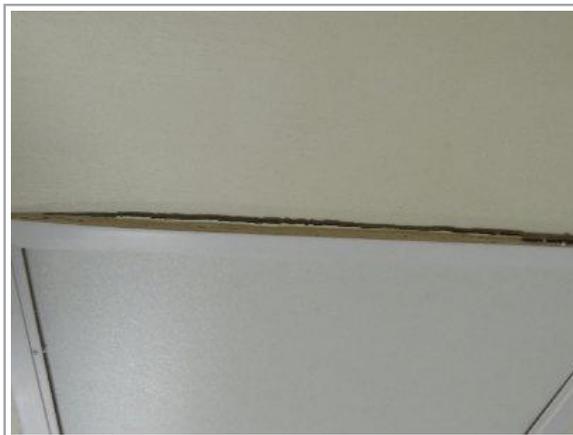
Damaged hatch surround

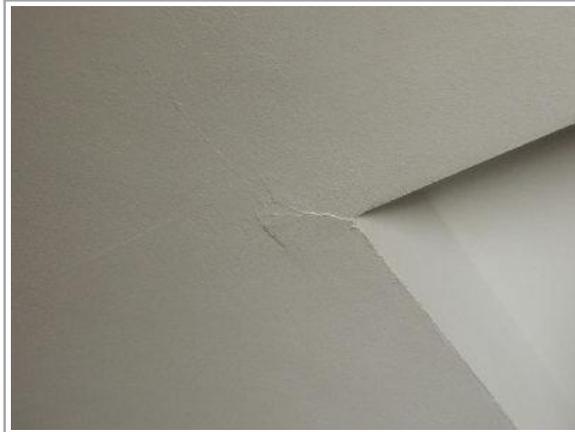
Slight damage

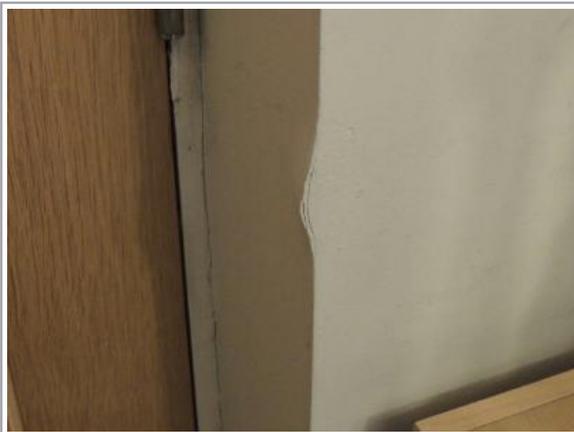
Shrinkage cracks inside should be cut out and filled with flexible filler and redecorated, and we also noted some dented beading to some of the wall corners.

Dented beading

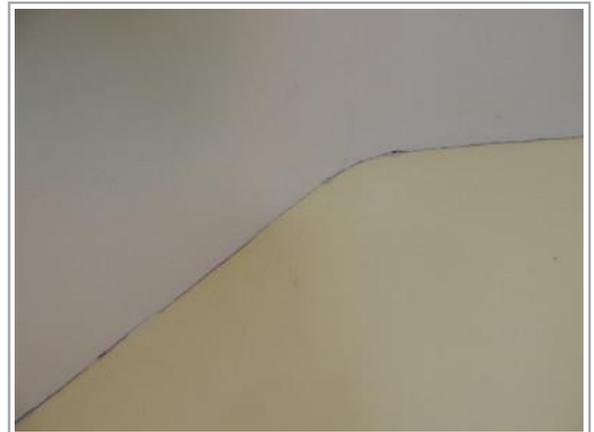
Shrinkage cracks

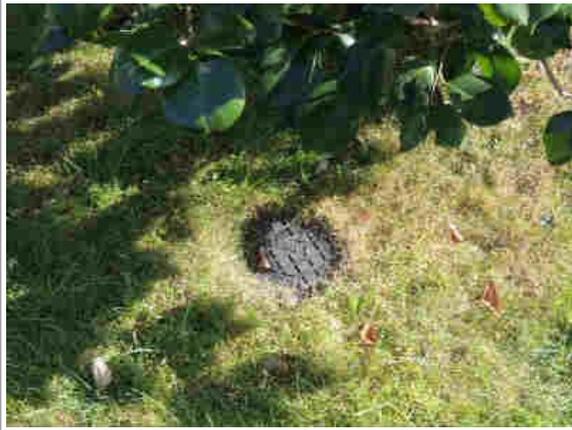
Drain grown over

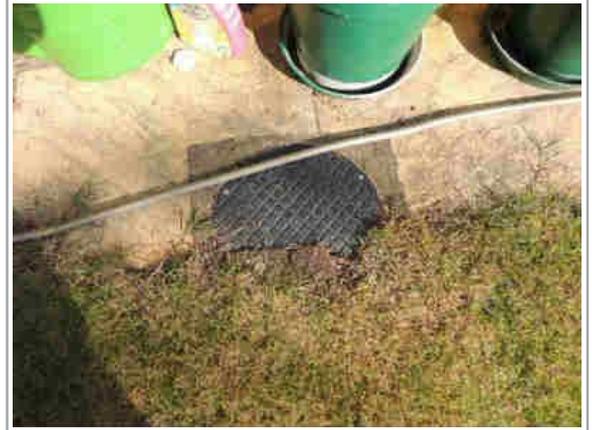
I was unable to lift the side and rear drain covers as they were screwed shut and overgrown as this would damage some of the lawn.

Cover grown over and screwed shut

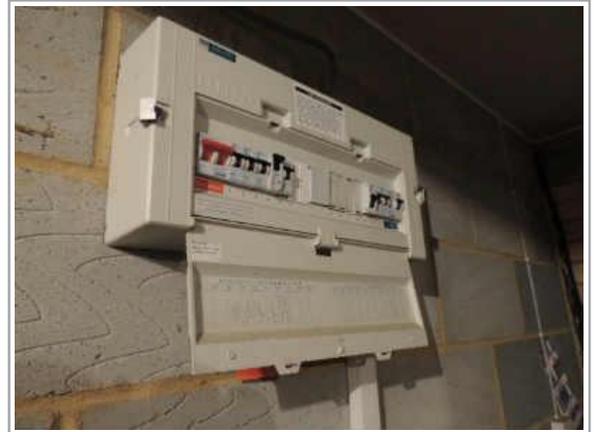
Original consumer unit

It is recommended that domestic electrical installations are tested at least once in every 10 years and on change of occupation. If there is no record of a test certificate within this period then I recommend that the system is tested by a qualified electrician.

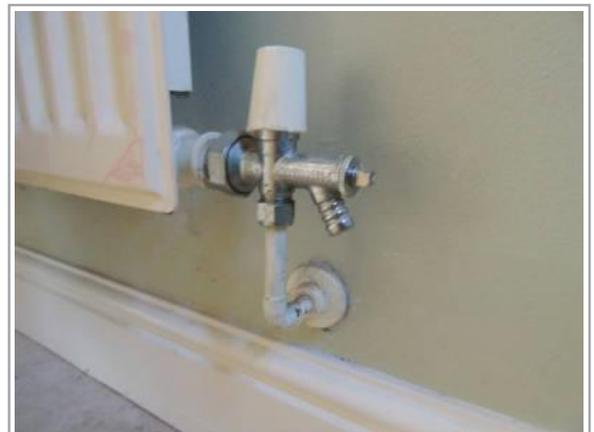
such systems because microbore will clog up a lot easier if your system becomes sludged up and tend to stop working. They are also easy to damage and can become clogged if the pipes bend/fold. The pump also has the added resistance of pumping around such a small bore pipe. You should budget for eventual replacement.

Microbore pipes

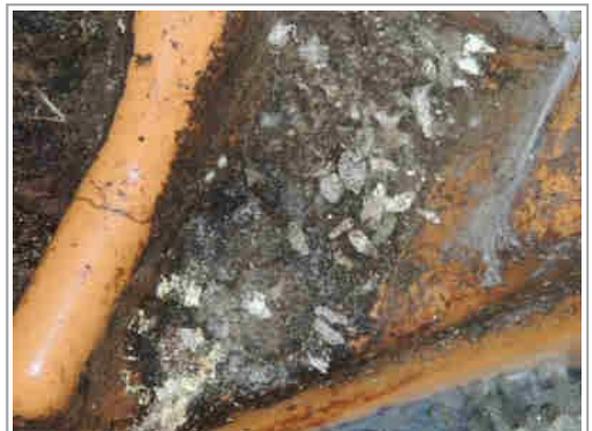
Old rat droppings

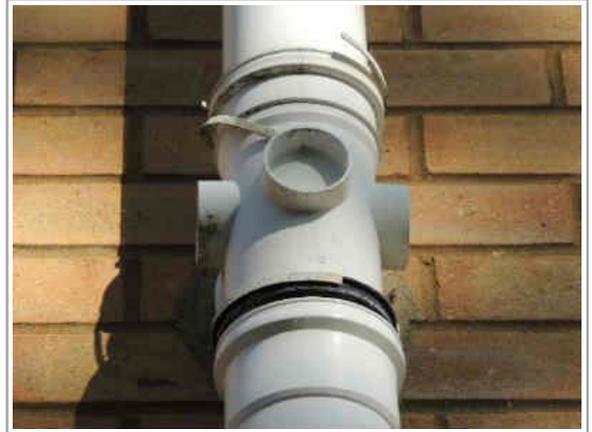
The joints to the soil and vent pipe at the rear are deteriorating and require replacement.

Rejoin pipe with new seals

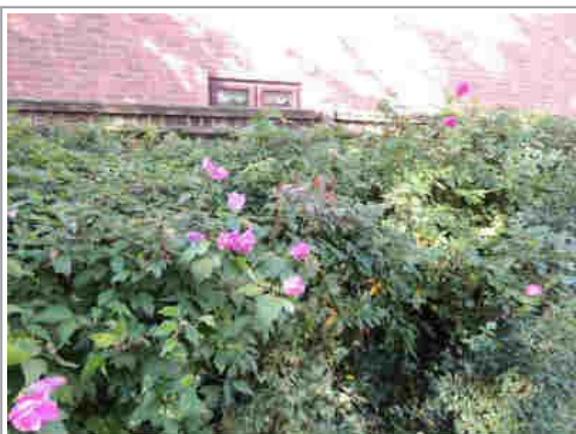
Garden fences were overgrown and not visible.

Fences overgrown

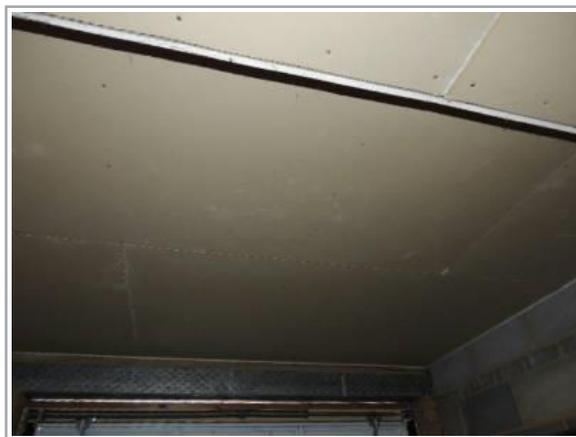
No access was possible to the roof void at the front projection, therefore we cannot comment as to the level of insulation or any other defects.

No hatch to roof void

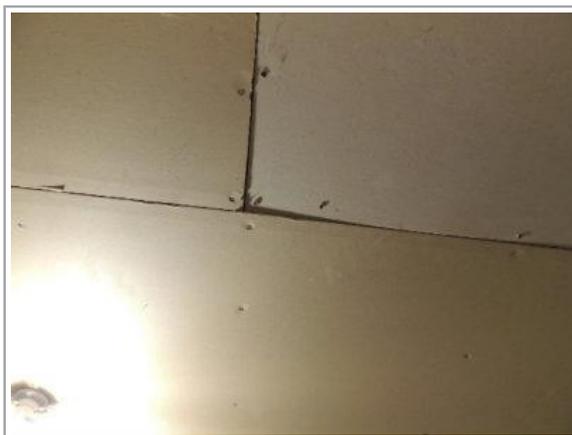
The ceiling in the garage has been roughly installed and has not been decorated.

Unfinished ceiling

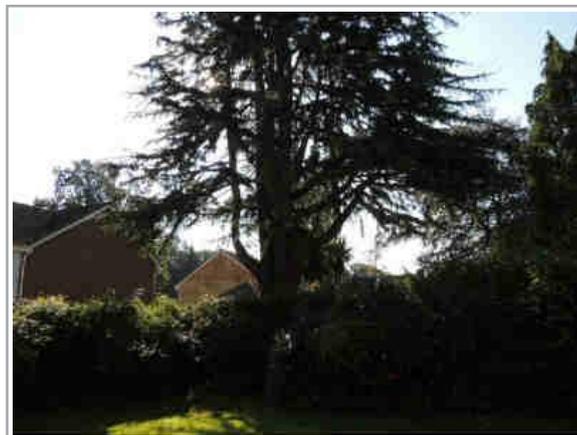
Neighbours tree

There is a tree to the rear of the home within influencing distance but this is on the neighbour's land and is subject to a Tree Preservation Order.

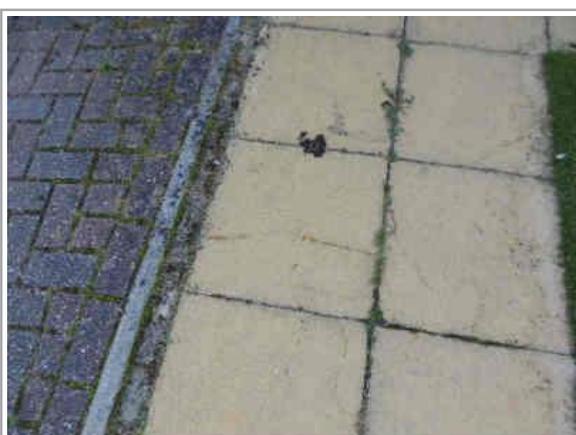
There is only a small patio to the rear of the home and I also noted some of the paving slabs are cracked to the front path. The block paving leading to the garage is uneven in places and vegetation requires removal between the bricks.

Cracked slabs

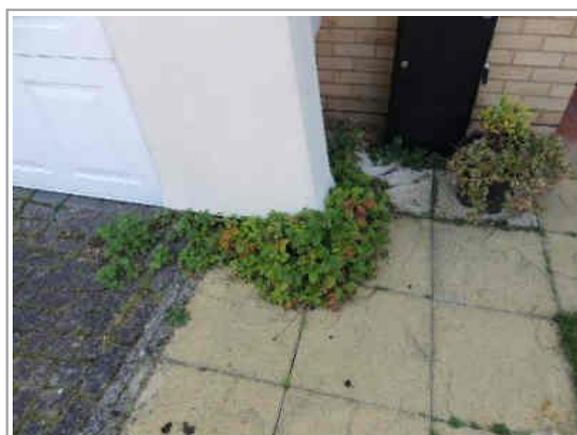
Slabs overgrown

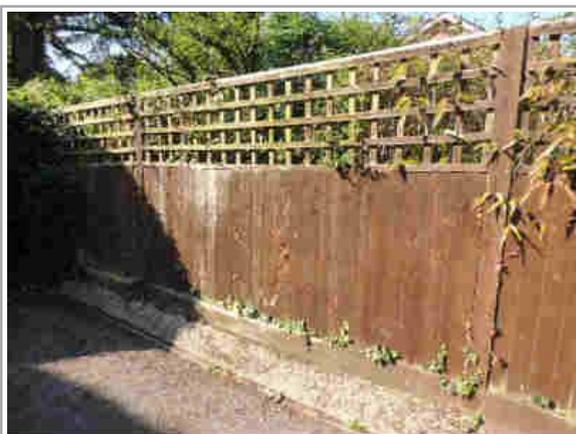
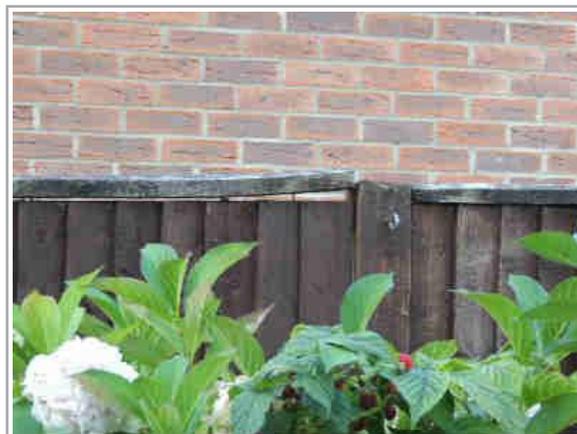
Worn fences

Old fences

Fences should be repaired or replaced.
