# Your survey and valuation report

25 Arcacia Avenue, Huxley, London NW1

22nd September 2021

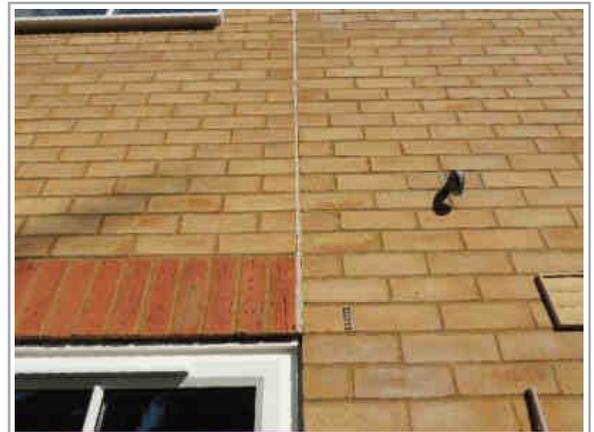
Correct expansion joint

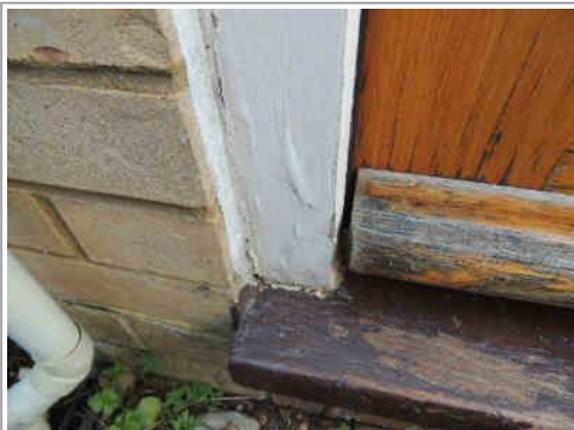
The majority of the property is reasonably decorated although the paintwork around the timber door to the side requires attention.

Old paint

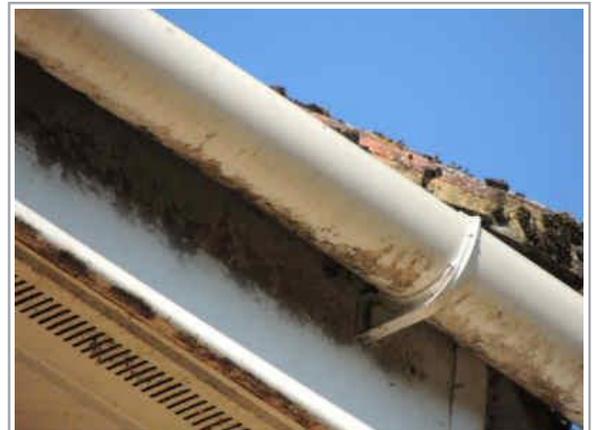
The plastic is quite dirty and would benefit from complete cleaning.

Dirty plastic

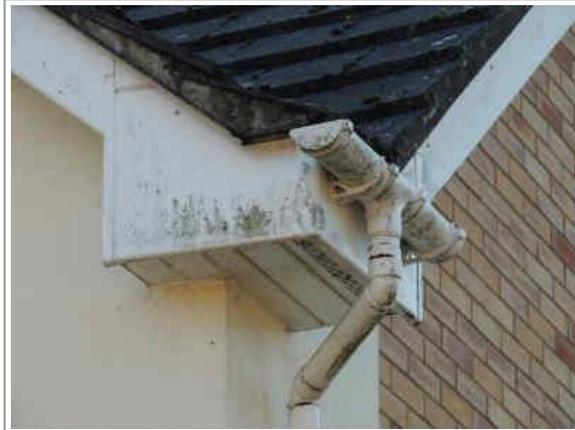
Dirty plastic

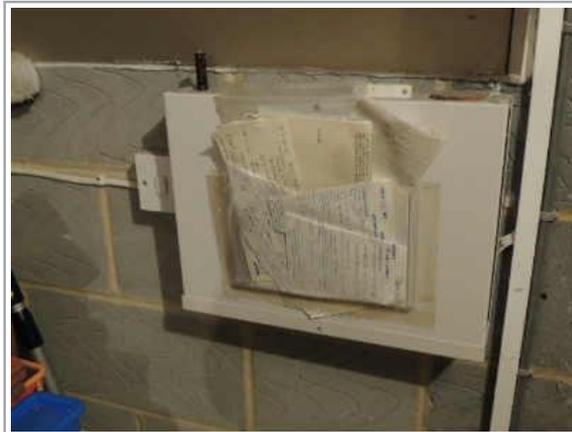
There is a burglar alarm in the home but this has been disconnected and cannot be used. This may adversely affect contents insurance premiums.

Redundant alarm

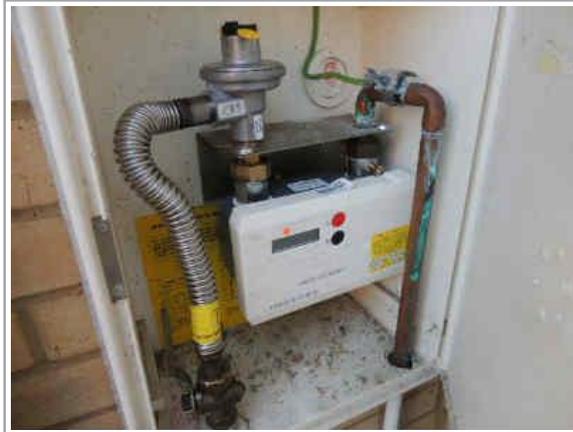
Gas meter

Although I have not carried out any tests I saw no evidence to suggest defects within the scope of my inspection and report.

It is recommended that domestic gas installations are tested at least once in every year and on change of occupation. If there is no record of a test certificate within this period then I recommend that the system is tested by a qualified Gas Safe registered engineer.

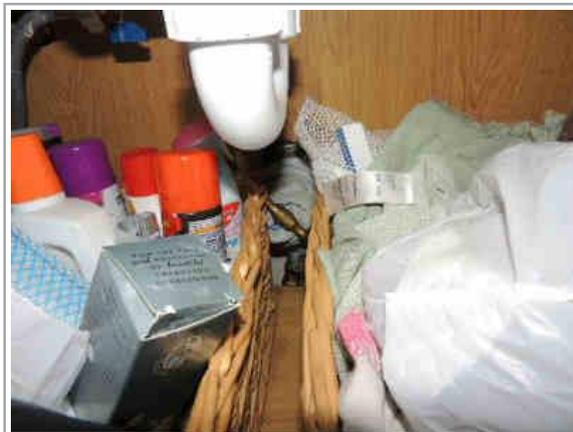
Stop cock

Although I have not carried out any tests, I saw no evidence of defects to the water supply within the scope of my inspection and report.

The home is situated in a hard water area and limescale would prematurely damage water fittings both fixed and portable.

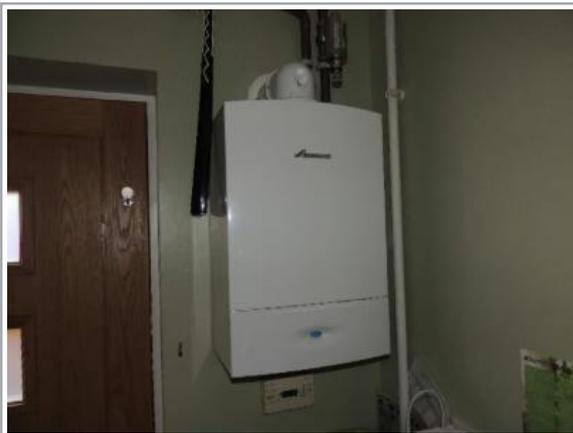
Boiler

Heating to the property is provided by the replacement Worcester Bosch boiler in the utility room. We were informed that this was installed around four years ago and was serviced in August 2021. All relevant certification should be obtained from the Legal Adviser including Building Regulation certificates for the replacement, any guarantees and service records.

Carbon monoxide detectors should be placed close to the boiler.

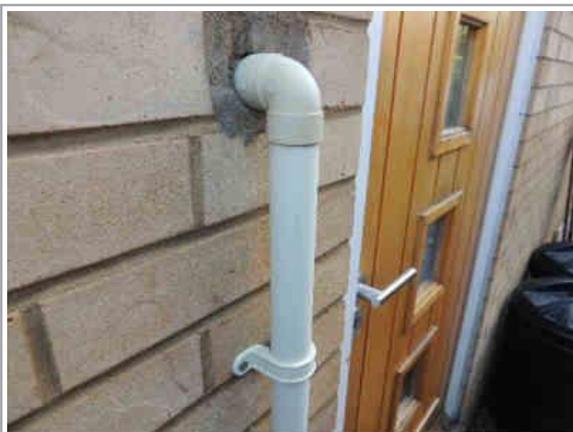
Insulation to the condensing water pipe outside is inadequate and requires attention.

Uninsulated condenser pipe

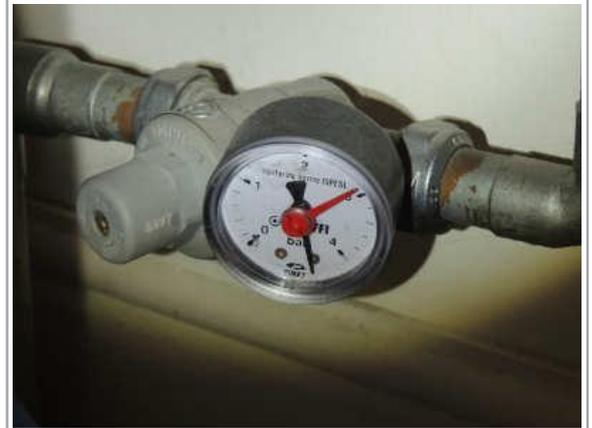
We note that the pressure to the boiler is at the absolute maximum which is probably too high and some adjustments may be required under the guidance of a central heating and hot water specialist.

Water at maximum pressure

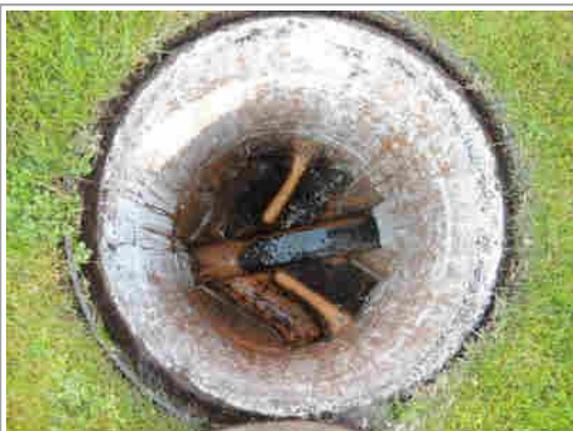
Drain

Although I have not lifted all drain covers I saw no evidence to suggest defects to the drainage system within the scope of my inspection and report.

The joints to the soil and vent pipe at the rear are deteriorating and require replacement.

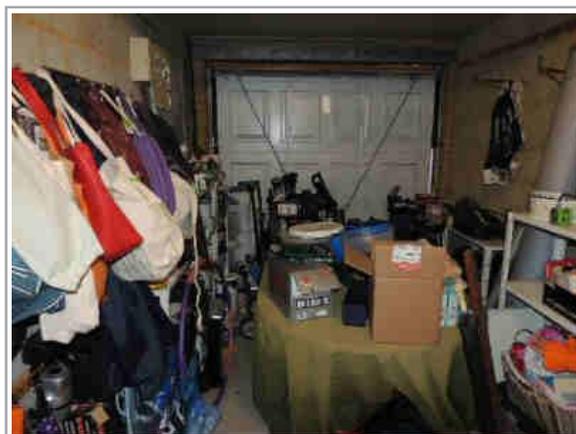
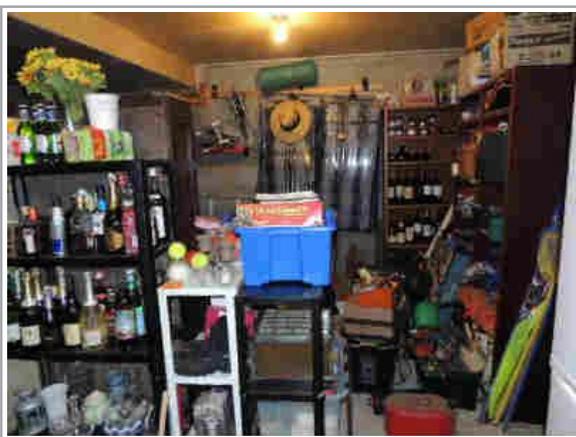
Garage full

The garage is in an acceptable condition for its purpose.

There is some cracking to the brickwork, although, as mentioned earlier, this is thermal in nature and not indicative of a structural problem.

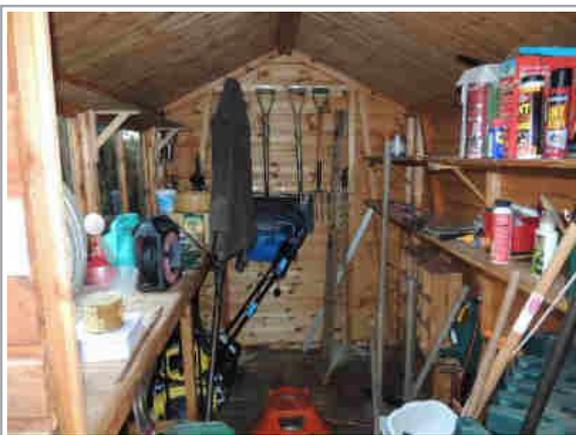
Shed

There is a basic timber shed in the rear garden which is beyond the scope of this survey.

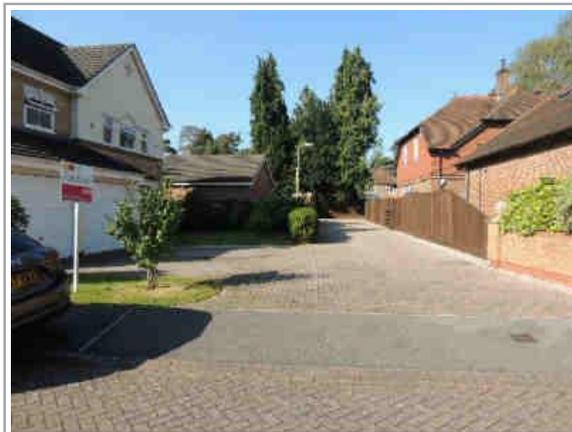
Shared private drive

There is a shared private access road to the home. Your Legal Adviser should check the legal arrangements are adequate.
